Service Bulletin

PRELIMINARY INFORMATION

Subject: DTC P0011 P0014 P0021 Or P0024 Light With No Drivability Concerns

Models: 2012-2015 Buick Lacrosse
2013-2015 Cadillac ATS
2012-2015 Cadillac CTS SRX
2012-2015 Chevrolet Captiva Sport Equinox
2012-2015 Chevrolet Impala Classic
2014-2015 Chevrolet Impala (W1)
2012-2015 GMC Terrain
with 3.0L LFW and 3.6L LFX engines

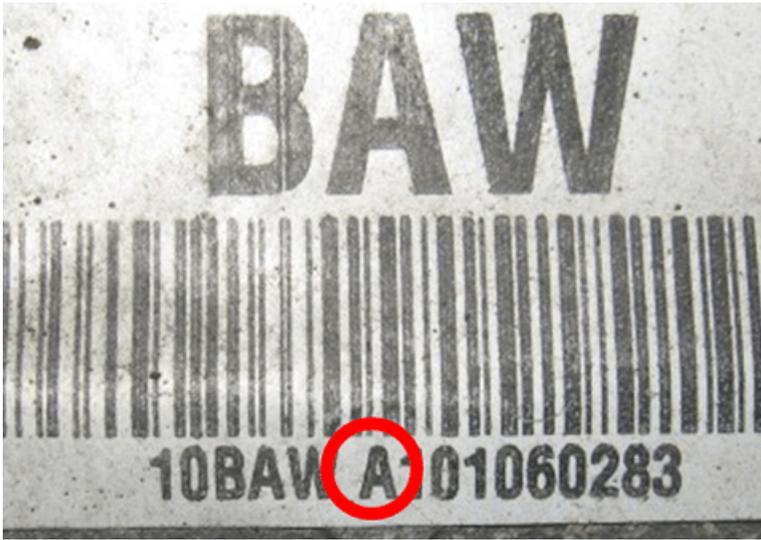
If you get a vehicle with one of these codes, and no other drivability concerns, inspect the engine EUN sticker for an A before the sequence number; before replacing the actuator.

The engine EUN sticker should be located on the engine left side below the left head or on the back of the right head.

(See the example below)

If there is an "A" before the sequence number then replace the OCV/Cam Actuator Solenoid Valve with a replacement "service" valve.

"DO NOT JUST SWAP FROM ANOTHER LOCATION."

The service OCV is from a different supplier and can make up the difference in the clearance that causes this concern.
